Queries	Response	
Click on the button to record the GPS location	25.33171727322042 92.33363734558225 1107.0 16.5	
Profile & Demography		
State	Meghalaya	
Select the District	East Jaintia Hills	
Select the Block	Khliehriat	
Select the Village	Rymbai	
Details		
Name of the Scheme	Construction of Community Hall for Pampyrthat Rymbai Village	
Name of the MP	Shri.V.H Pala	
Year recommended	01-Jan-2017	
Amount of sanction by the DC	500000	
Date of sanction by the DC	04-May-2017	
Delay in Sanction	No	
Reason for delay in sanction		
Please mention the other reason:		
Released Funds		
Amount 1st Installment	250000	
Date 1st Installment	20-Nov-2017	
Amount 2nd Installment	200000	
Date 2nd Installment	20-Aug-2018	
Amount 3rd Installment	50000	
Date 3rd Installment	31-Oct-2019	
Delay in Fund Release	No

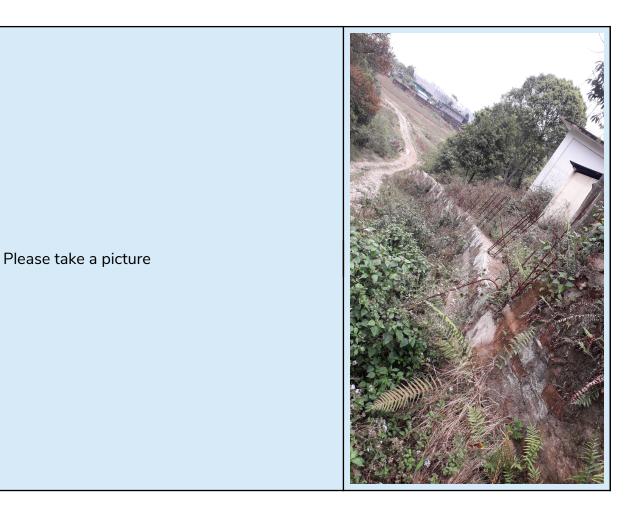
Findings/Observation:	 During inspection the Team found that construction of Retaining wall is under progress. The Member of Local committee informed that they demand for release of the 2nd installment to complete the Scheme . The Assistant Engineer has been advised to look into the matter with the Committee for release of the 2nd installment after the Committee has submitted the requireddocuments such as UC,Photographs. etc. The member also advised to erect a plaque with complete details of the scheme such as Name of MP, Name of Scheme, Date of Starting and Completion, Amount sanction. etc Dimensions : Length: 70 meters Avg.Height: 3.00 meters Width:0.60meter
Quality of work:	Good

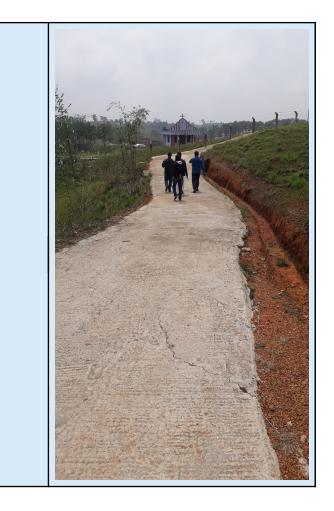
Findings/Observation:	 1.During inspection the team found that the construction of Approach road is completed. It is seen that due to site condition addition work is executed i.e Slab culverts, Retaining wall. 2. The member of committee has been advised to erect a plaque mentioning the Name of MP Name of Scheme, Amount sanction, Date of Starting and completion, etc. 3. The member informed that UC and Photographs has been submitted to the Block Office for releasing of the 2nd installment. 4. The Assistant Engineer has been advised to take matter with the member committee for release of the 2nd installment. 5. Dimensions: Road Length : 90meters width: 3.90meters Slab Culvert: (3.90x1.4)meters
Quality of work:	Good
